Manhole Inspection Summary

Manhole # S09A1_016MH

Location Address: **1237 Haverhill Rd**

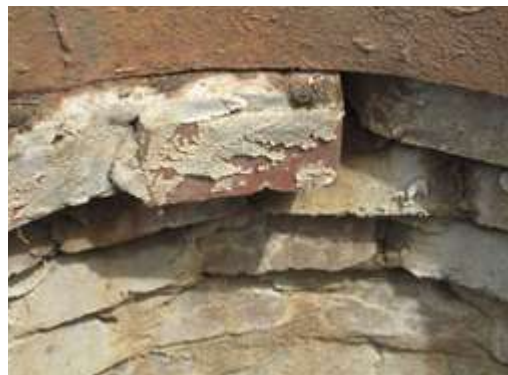
Defect 2

Condition: ☐ Sound ☐ Cracked ☐ Root Intrusion ☒ **Loose Brick** ☐ Deteriorated

Infiltration: ☐ None ☐ Joint ☐ Cracks ☒ **Mortar** ☐ Roots ☒ **Wall**

missing bricks and mortar chimney, signs of infiltration

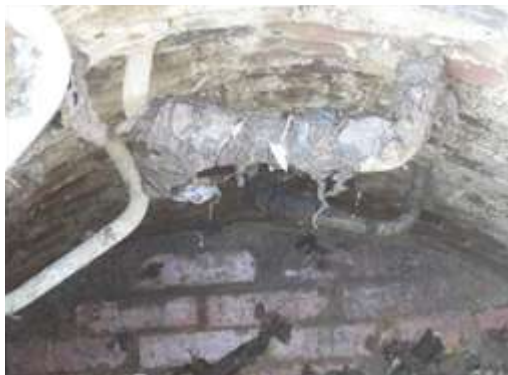
Defect 1

☒ **Evidence Of Surcharge**

Depth: **2.5** (ft.) ☐ Active Surcharge Present

evidence of surcharge and of infiltration
@ frame adjustment

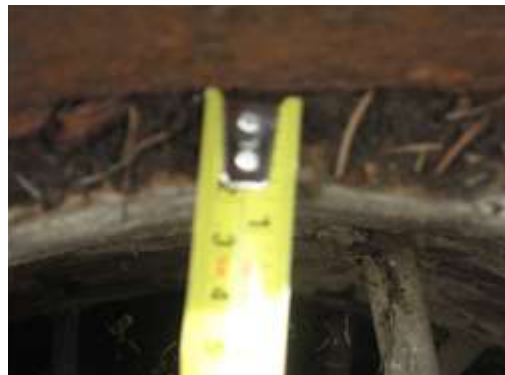
Defect 3

Offset: **1** (in.)

1" offset
